2018 Annual GLOEMMP Report

Globeville Landing Outfall Vasquez Boulevard and Interstate 70 Superfund Site Operable Unit 2 Denver, Colorado

May 13, 2019

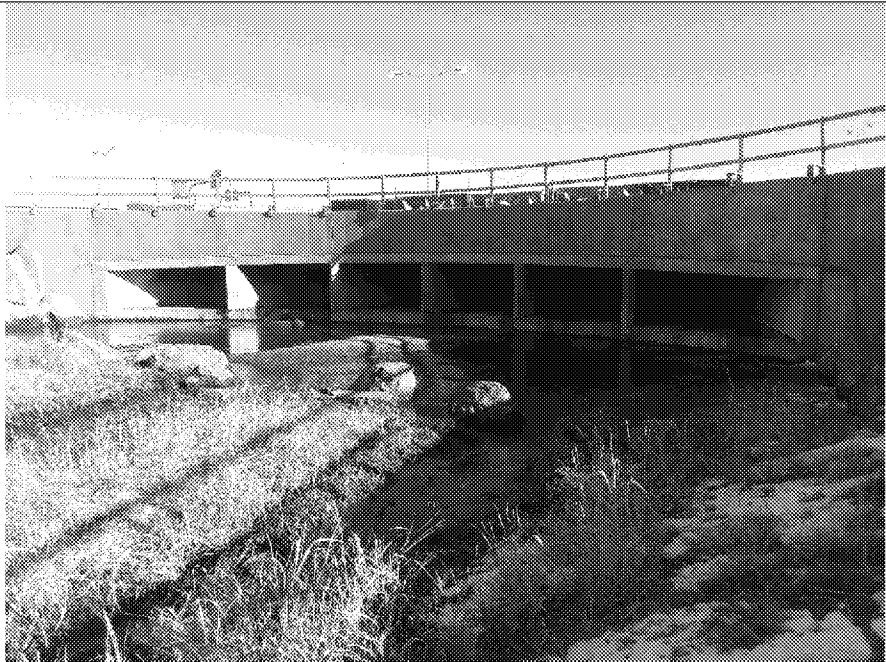
Photograph ID: 094522

Photo Location: Coliseum outlet – GLO channel	
Direction: Northeast	
Inspection Date: 11/26/2018	
Comments: The storm water drainage system is not fully connected upstream of the Coliseum outlet. Minimal flow observed.	
Photograph ID: 101632

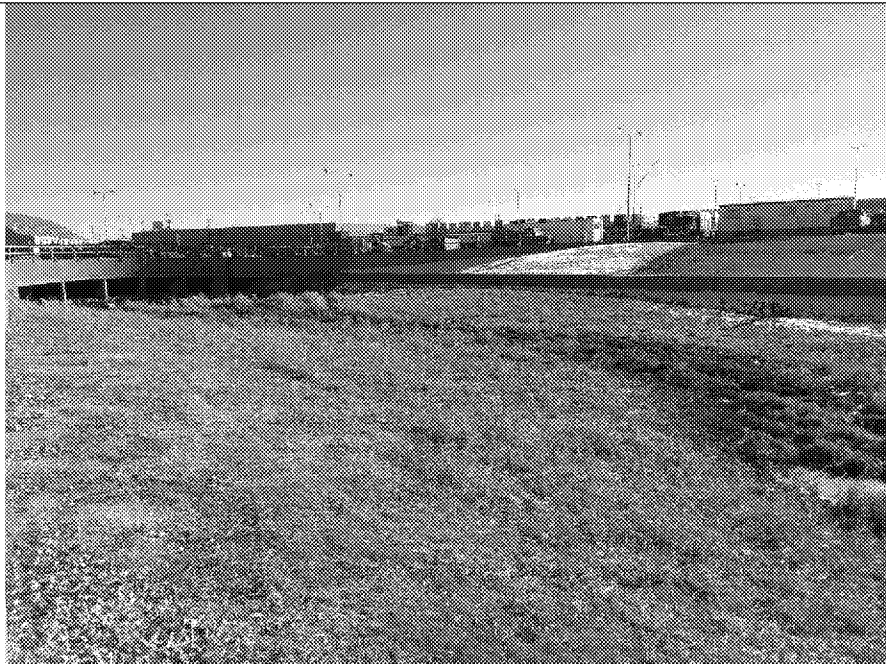
Photo Location: Looking toward Coliseum outlet	
Direction: Southeast	
Inspection Date: 11/26/2018	
Comments: Grasses are well established near the trickle channel. Some additional seeding may be needed along the channel walls.

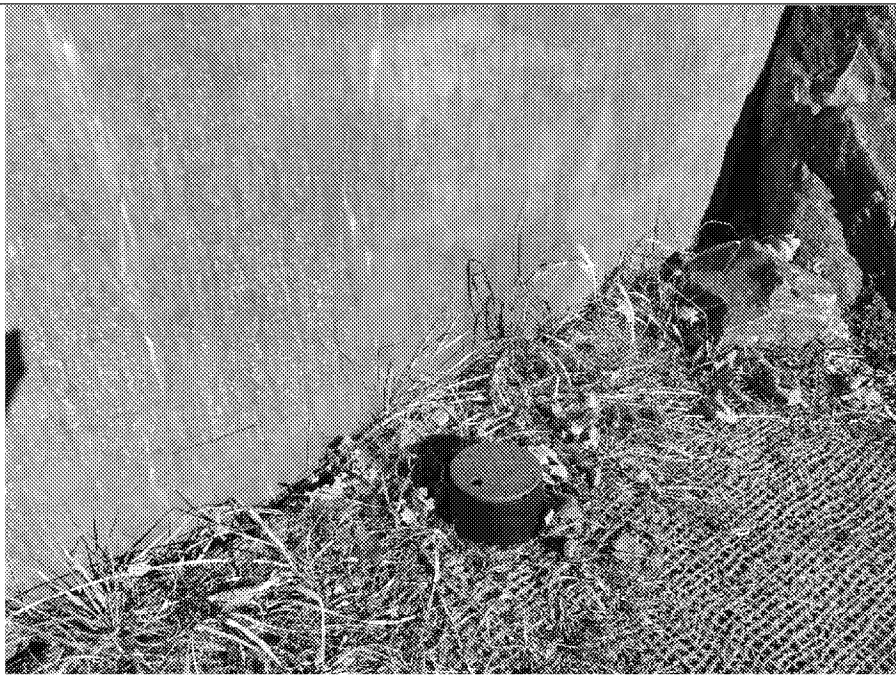
Photograph ID: 101156

Photo Location: Coliseum outlet – Electrical Leak Location Copper Wire Box	
Direction: Aerial (down)	
Inspection Date: 11/26/2018	
Comments: Batten bar copper wire and central GLO channel copper wire labeled and protected in the irrigation box.

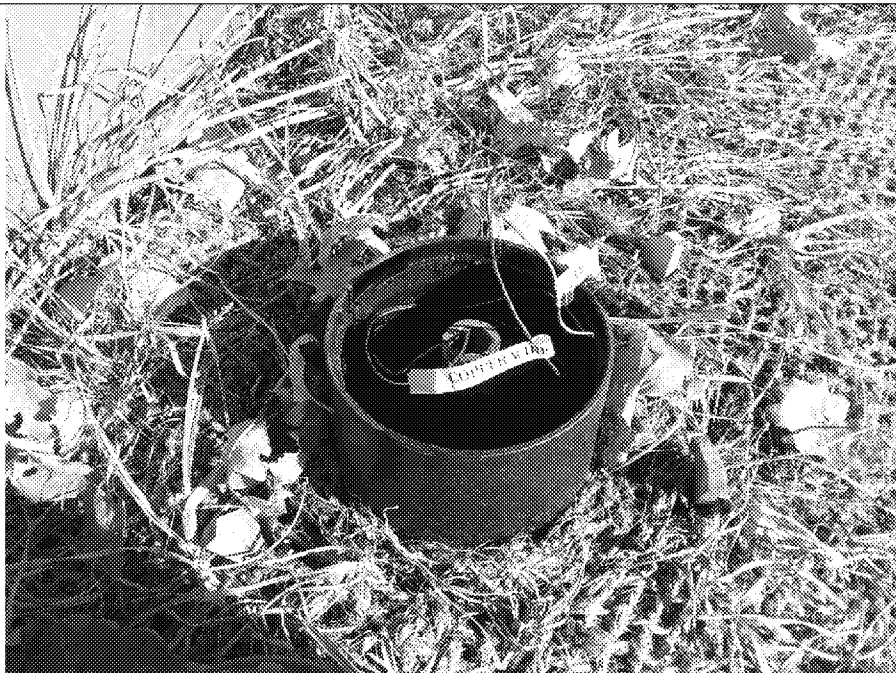
Photograph ID: 101232	
Photo Location: Coliseum outlet – Electrical Leak Location Copper Wire Box	
Direction: Aerial (down)	
Inspection Date: 11/26/2018	
Comments: Batten bar copper wire and central GLO channel copper wire labeled and protected in the irrigation box.

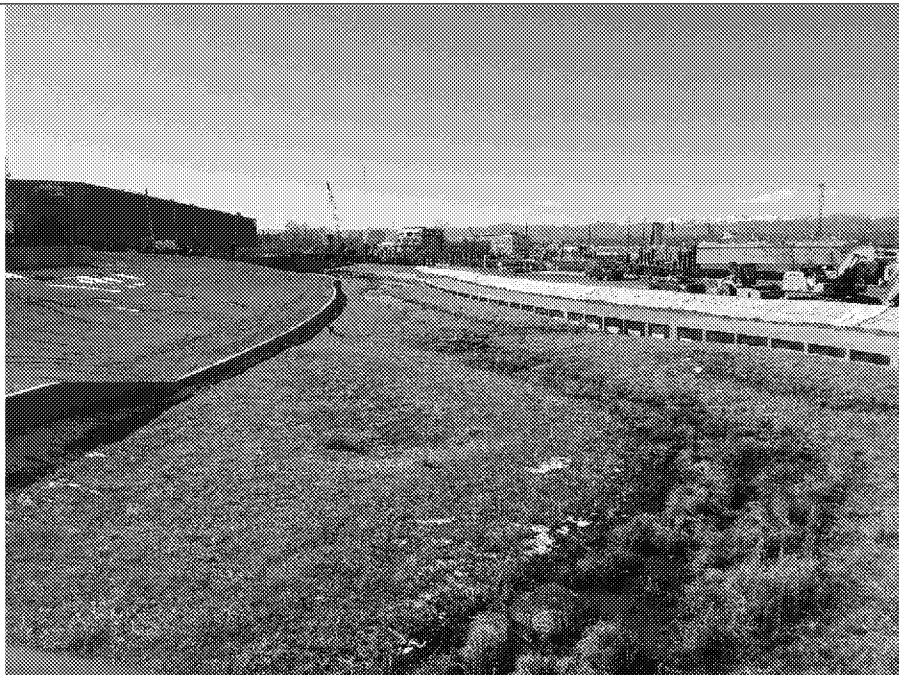
Photograph ID: 110210

Photo Location: GLO channel – looking toward Arkins outlet	
Direction: Southwest	
Inspection Date: 11/26/2018	
Comments: Grasses well established in the trickle channel. Some additional seeding may be needed along channel walls. Some depressions noted within the island areas.	
Photograph ID: 101136

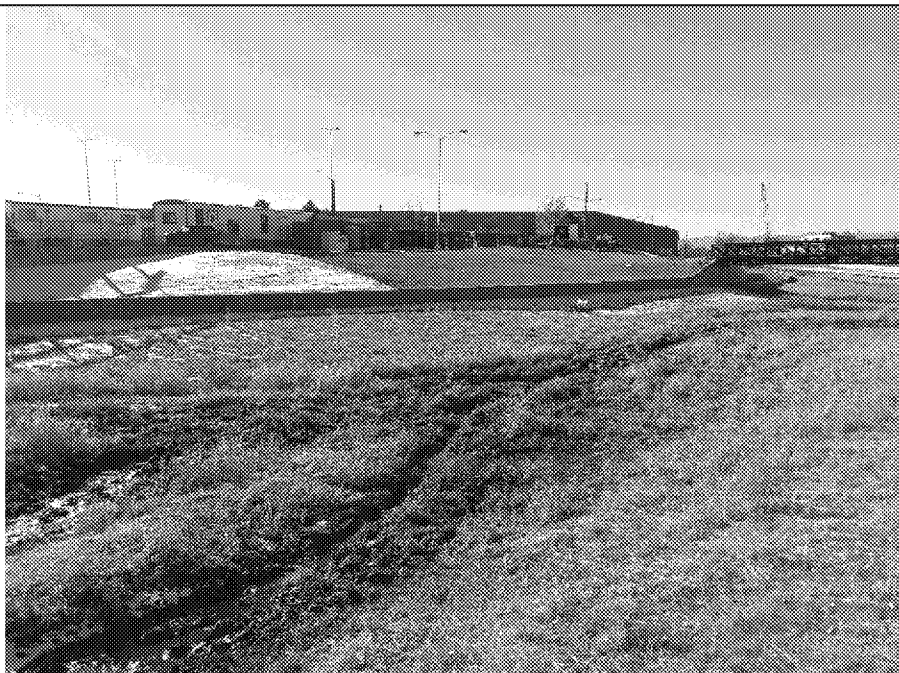
Photo Location: GLO channel – looking toward pedestrian bridge	
Direction: Southwest	
Inspection Date: 11/26/2018	
Comments: Grasses well established in the trickle channel

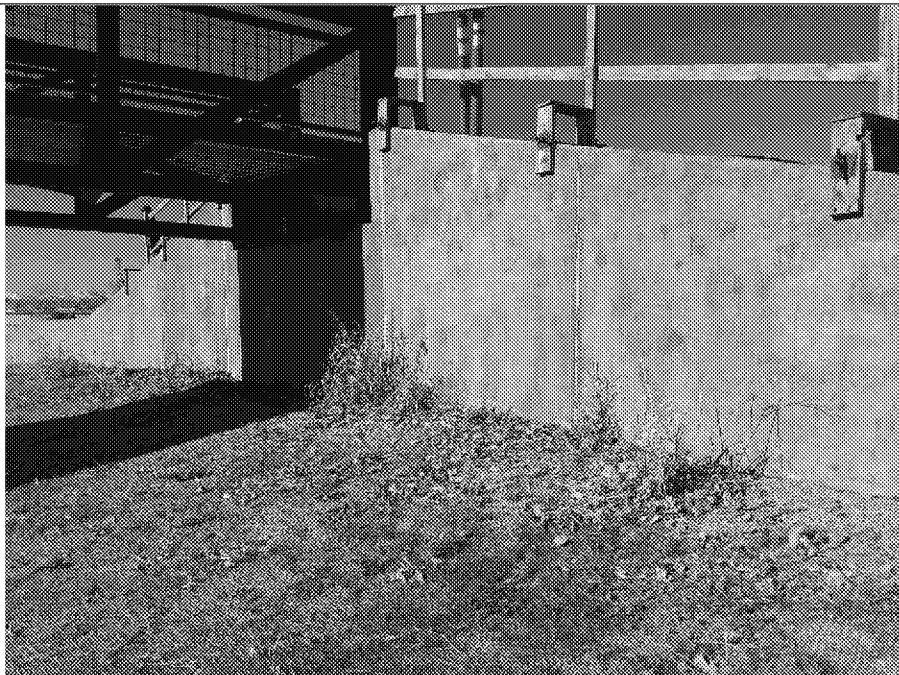
Photograph ID: 101718

Photo Location: Pedestrian bridge and GLO channel wall	
Direction: Northwest	
Inspection Date: 11/26/2018	
Comments: No structural issues noted for the GLO channel walls.	
Photograph ID: 101746

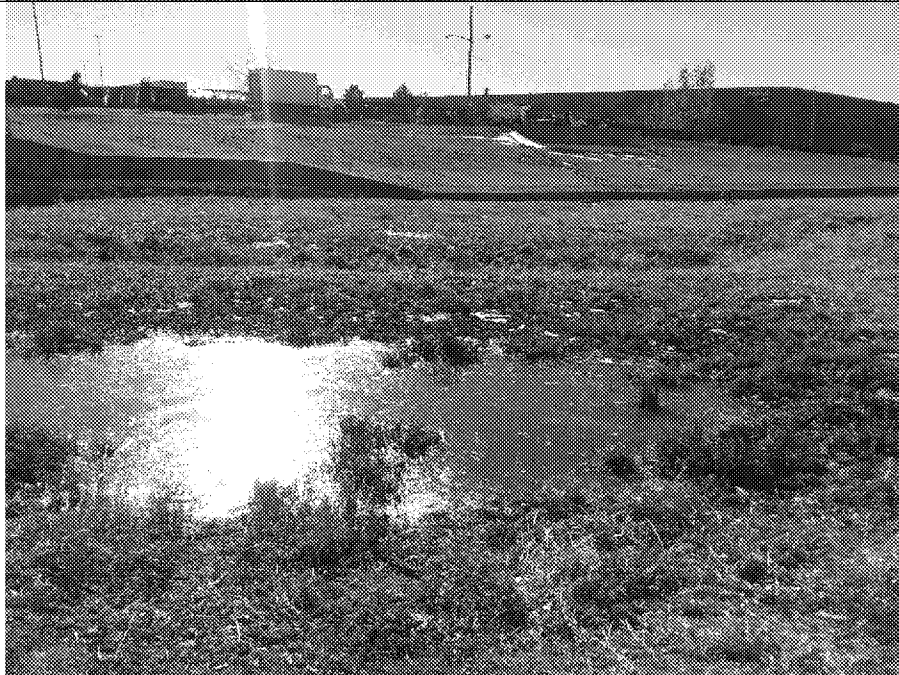
There was minor ponding noted in the channel (photograph 101746, **Appendix A**). Ron Frobel, liner expert, confirmed on January 23, 2019, that ponding is not a concern for the liner system. Generally, the native grass vegetation is establishing well in the channel with the exception of the Arkins outlet side and along some sections of the channel walls. Grass plugs will be installed within the void-filled riprap area near the Arkins outlet in the spring of 2019. Grass seeding along the walls will also occur at that time. No structural issues were observed along the GLO channel walls or around the channel outlets. The south lateral drain boxes were blocked per the June 2018 Storm Event Memorandum (Merrick, 2018).

Photo Location: GLO channel – ponding area	
Direction: Southwest	
Inspection Date: 11/26/2018	
Comments: Slight ponding observed within the GLO channel. Ron Frobel, liner expert, confirmed on 1/23/19 that ponding is not a concern for the liner system.

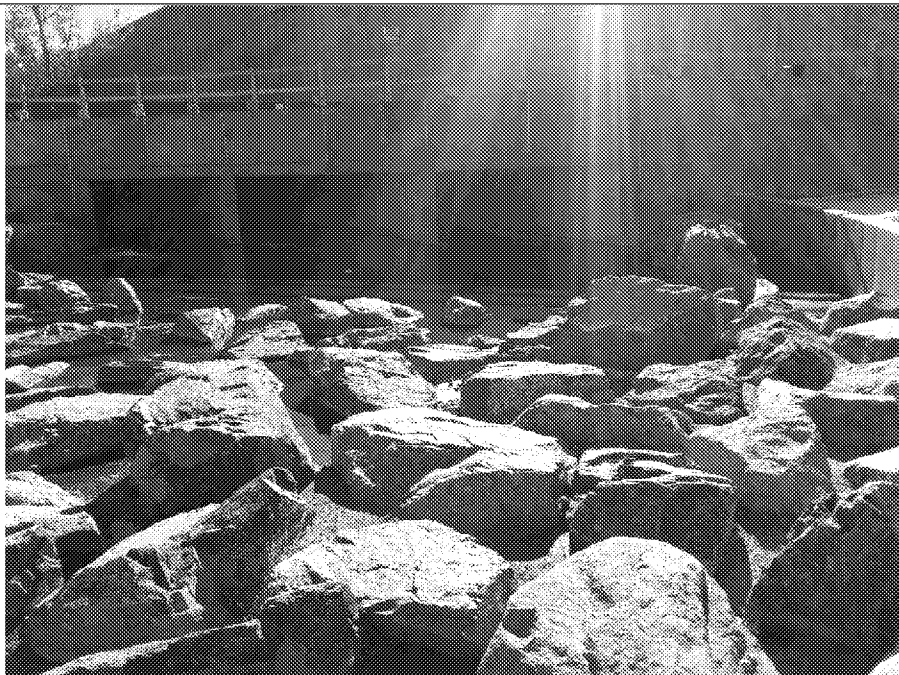
Photograph ID: 103512

Photo Location: Arkins Court outfall	
Direction: South	
Inspection Date: 11/26/2018	
Comments: Moderate flow. No cracks observed in the channel walls. No cracks observed within the grouted boulder section.	
Photograph ID: 103556

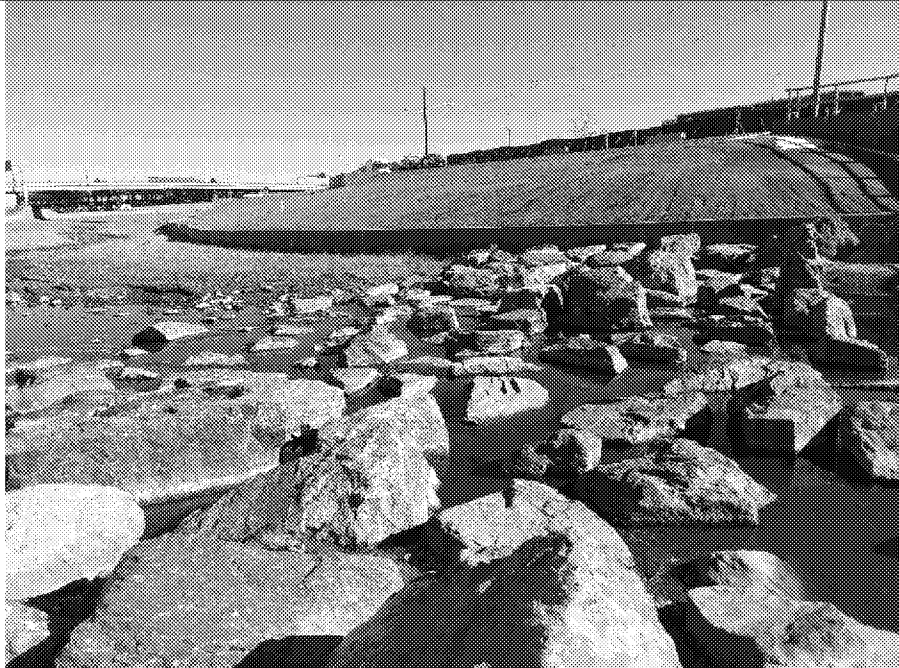
Photo Location: Arkins Court outfall – grouted boulder section	
Direction: East	
Inspection Date: 11/26/2018	
Comments: No cracks observed within the grouted boulders.

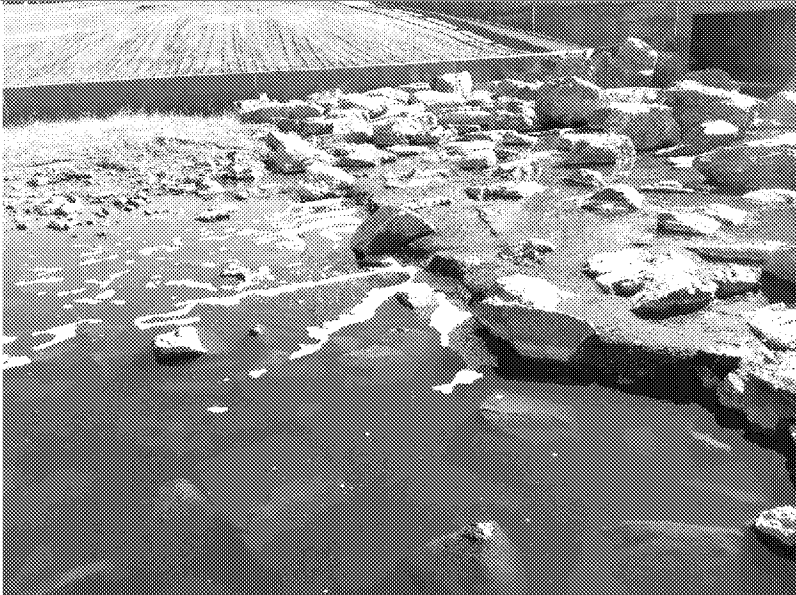
Photograph ID: 103615

The highly visible barrier grid was not exposed in any areas. There was visible settlement and erosion (photograph 103615, **Appendix A**) at the Arkins Court channel outlet (Arkins outlet) to the northeast of the grouted boulder section. Erosion and settlement repair were completed in December 2018 with the installation of void-filled riprap, which extends 89 feet beyond the grouted boulders within the channel. Repair photographs can be found in **Appendix B**.

Photo Location: Arkins Court outfall	
Direction: Southeast	
Inspection Date: 11/26/2018	
Comments: Erosion observed following installation of grouted boulders and buried riprap in July 2018. The barrier grid is not visible. Additional channel modifications were completed on 12/3/18 which included placement of void-filled riprap in the trickle channel for 89' beyond the grouted boulders at the Arkins outlet.	
Photograph ID: 103625

Ames Construction implemented this erosion control measure in December 2018. Eighteen inches of topsoil were removed along the trickle channel and replaced with a layer of void-filled riprap for 89 feet beyond the grouted boulders at the Arkins outlet (see **Appendix B**). Grass plugs and additional seeding will be completed in the spring of 2019.

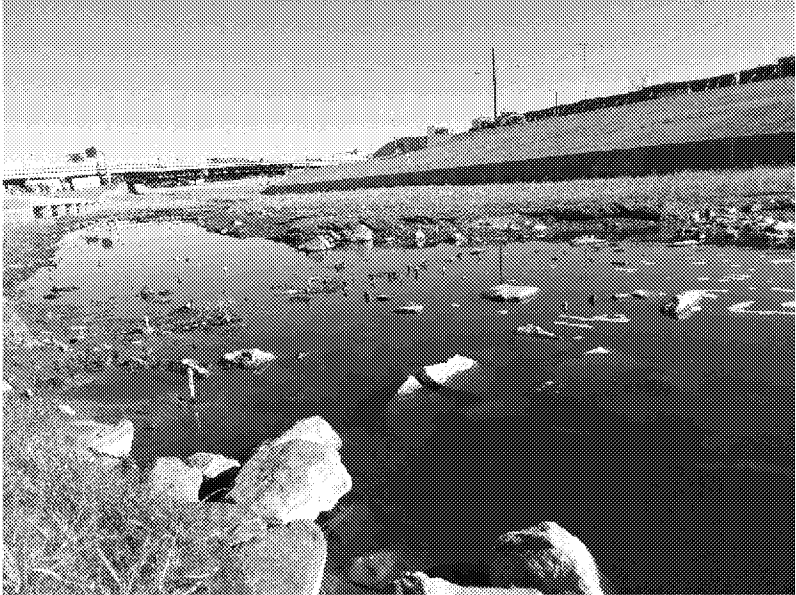
Photo Location: Arkins Court outfall	
Direction: Northeast	
Inspection Date: 11/26/2018	
Comments: Erosion observed following installation of grouted boulders and buried riprap in July 2018. The barrier grid is not visible. Additional channel modifications were completed on 12/3/18 which included placement of void-filled riprap in the trickle channel for 89' beyond the grouted boulders at the Arkins outlet.

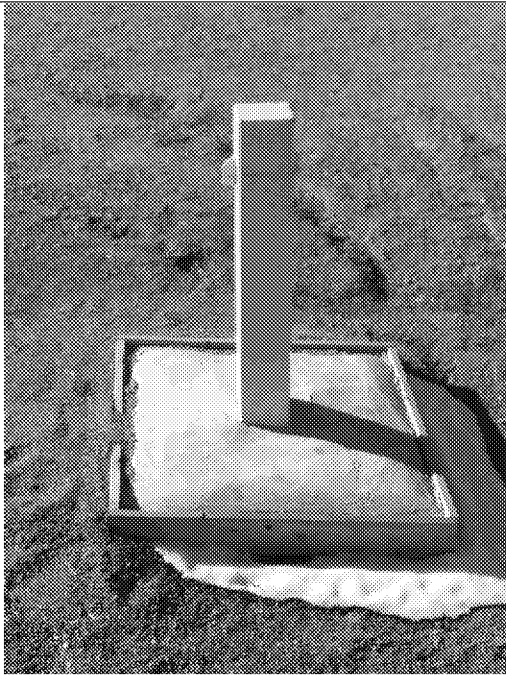
Photograph ID: 105800

Photo Location: Piezometer – PZ-1	
Direction: Aerial (down)	
Inspection Date: 11/26/2018	
Comments: No piezometer damage observed.	
Photograph ID: 105910

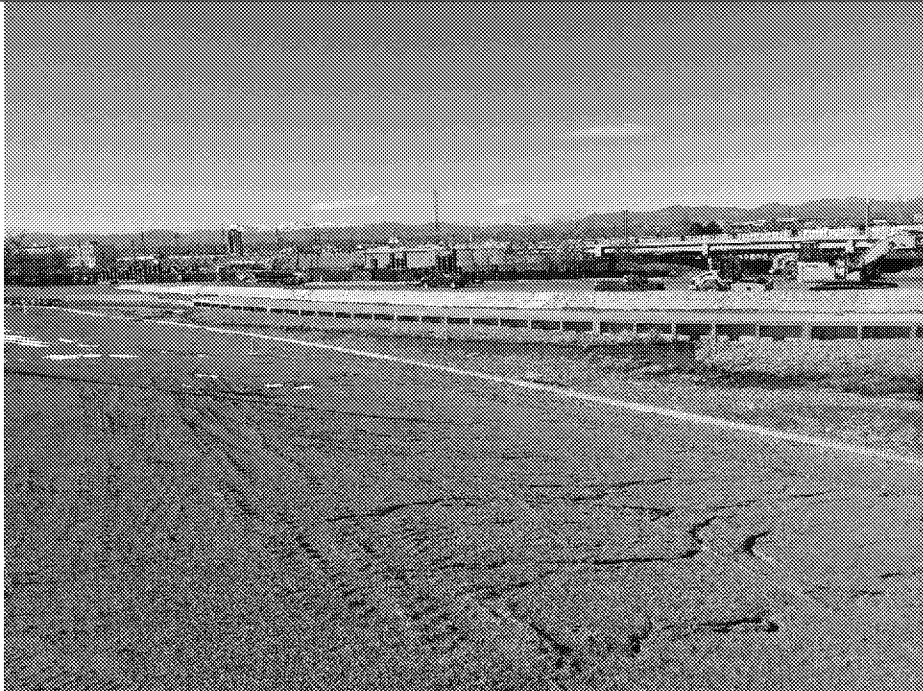
Photo Location: South of GLO Channel – piezometers (PZ-2 and PZ-3)	
Direction: Northwest	
Inspection Date: 11/26/2018	
Comments: No piezometer damage observed.

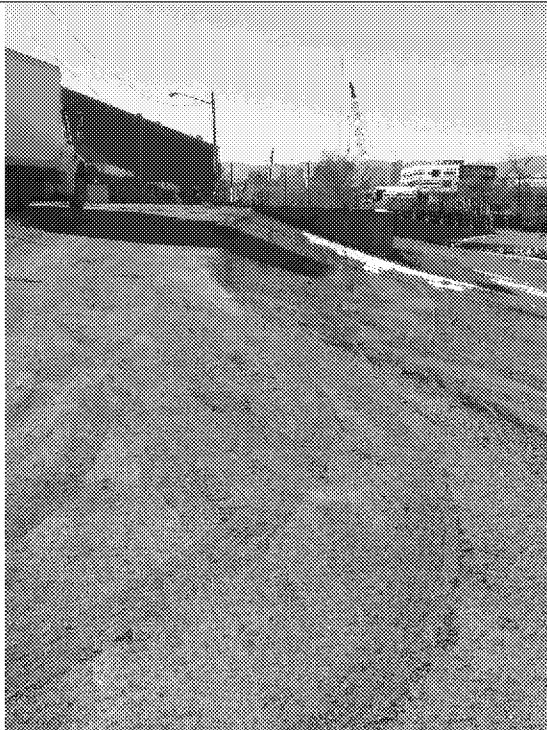
Photograph ID: 105856

Photo Location: Sheet pile wall area		
Direction: Southwest		
Inspection Date: 11/26/2018		
Comments: No drilling, grading, or excavation activities observed near the sheet pile wall area or piezometers.		
Photograph ID: 101046

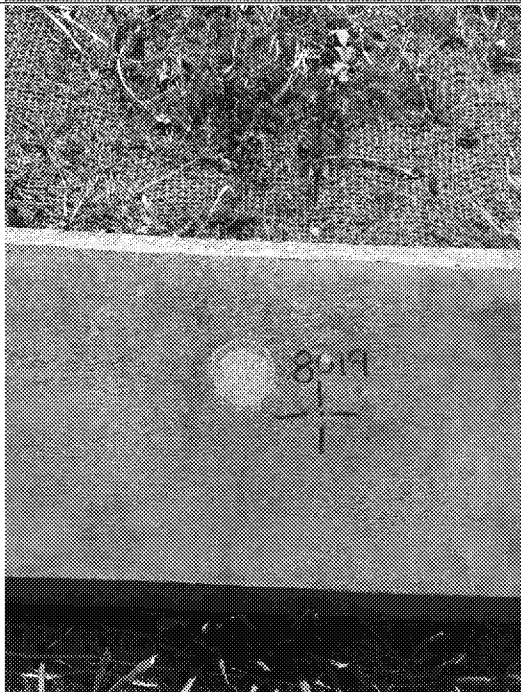
Photo Location: GLO channel wall survey point		
Direction: Arial (down)		
Inspection Date: 11/26/2018		
Comments: GLO channel wall survey markers clearly visible at all survey locations.

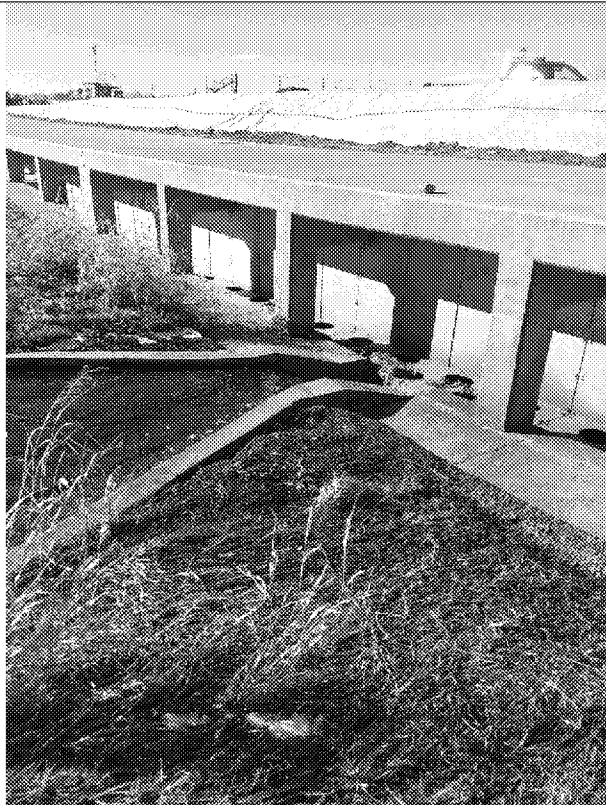
Photograph ID: 102915

Photo Location: GLO channel outlet to South Platte River	
Direction: Northwest	
Inspection Date: 11/26/2018	
Comments: No damage observed to the channel structure. Some additional grass seeding needed along channel wall. South lateral drain boxes partially blocked.	
Photograph ID: 100150

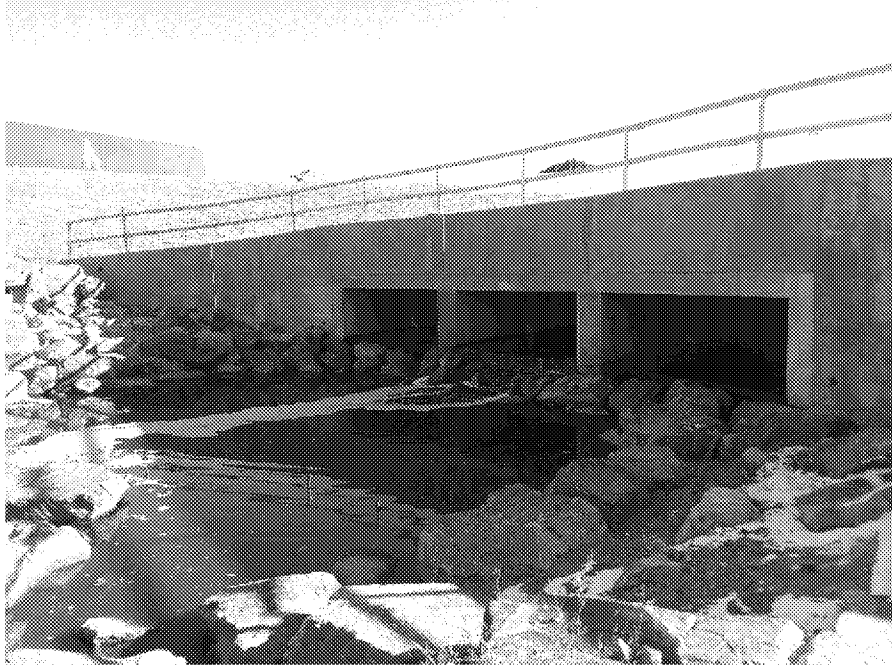
Photo Location: South Platte River outfall	
Direction: East	
Inspection Date: 11/26/2018	
Comments: No structural damage observed. No seeps visible around the outfall structure, grouted boulder area, and the slope side.

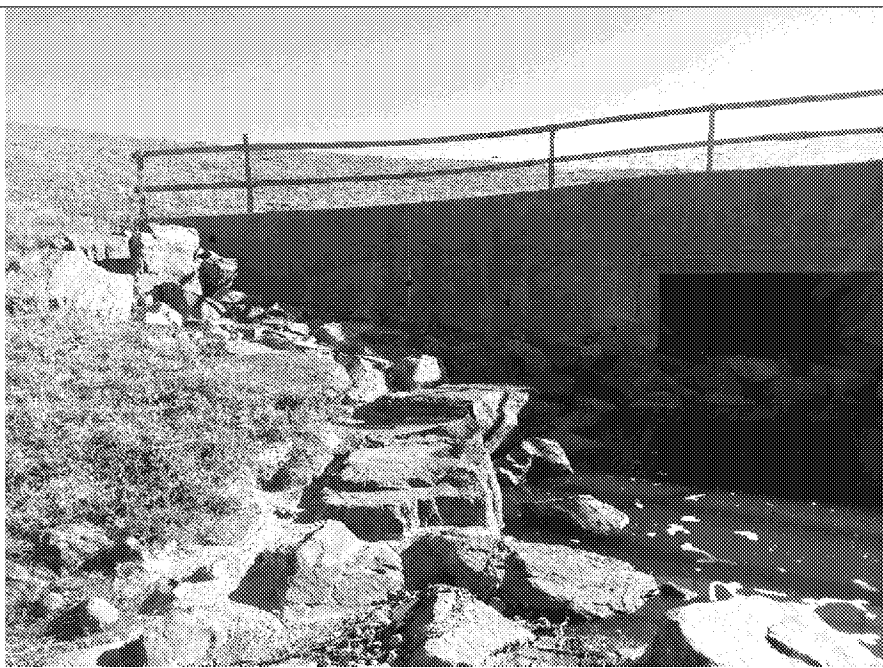
Photograph ID: 100648

Photo Location: South Platte River outfall	
Direction: Southeast	
Inspection Date: 11/26/2018	
Comments: No structural damage observed. No seeps visible around the outfall structure, grouted boulder area, and the slope side.

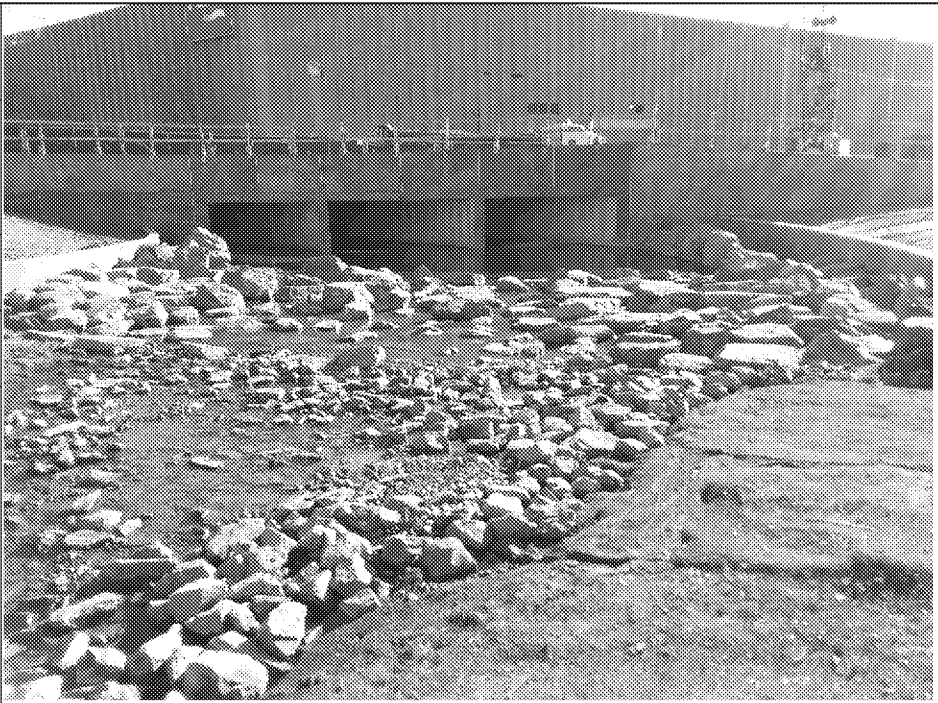
Photograph ID: 133316

Photo Location: Arkins Court Outlet GLO Channel	
Direction: Southwest	
Inspection Date: 12/7/2018	
Comments: Erosion Repair	
Photograph ID: 133323

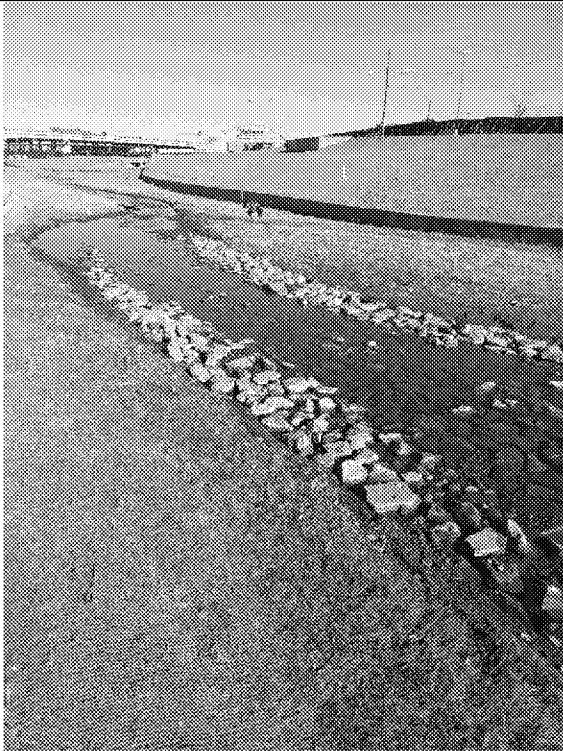
Photo Location: Arkins Court Outlet GLO Channel	
Direction: East	
Inspection Date: 12/7/2018	
Comments: Erosion Repair
